ANNUAL REPORT FOR 2010

Unnamed Tributary to Howell Branch Wayne County
TIP No. R-2554BA – Site 5

Prepared By:
Roadside Environmental Unit & Natural Environment Unit
North Carolina Department of Transportation
October 2010

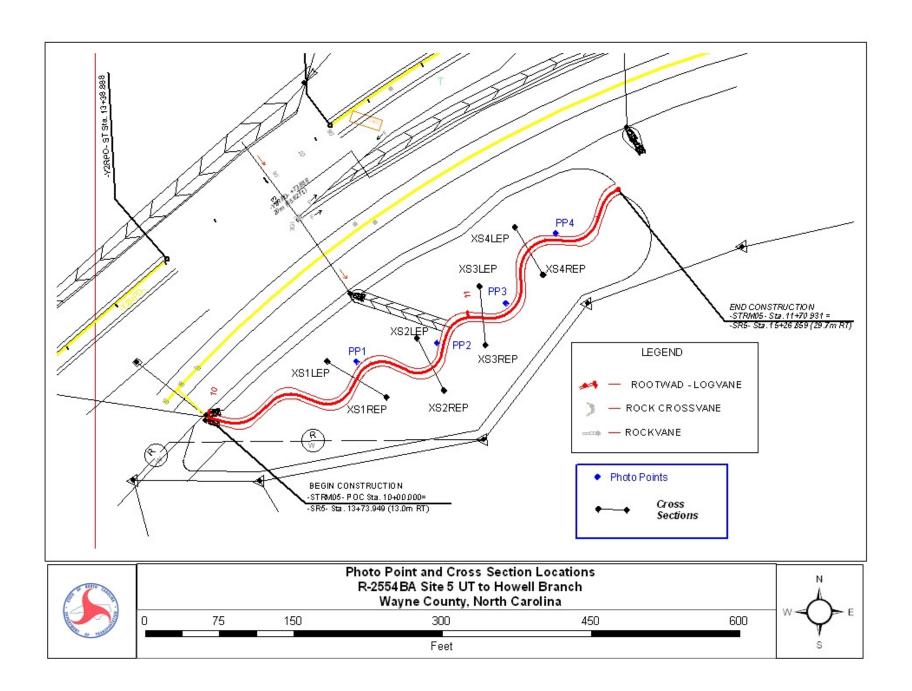
Vegetation Plot #2 taken from PP#2

Site Notes: The black willow and silky dogwood live stakes were surviving along sections of the streambank. Other vegetation noted included lespedeza, cattail, fennel, and various grasses.
